# 406 MHz EPIRB False Alerts

## Cause and Prevention of False Alerts

January 2009

L. T. Yabrough, U.S. Coast Guard

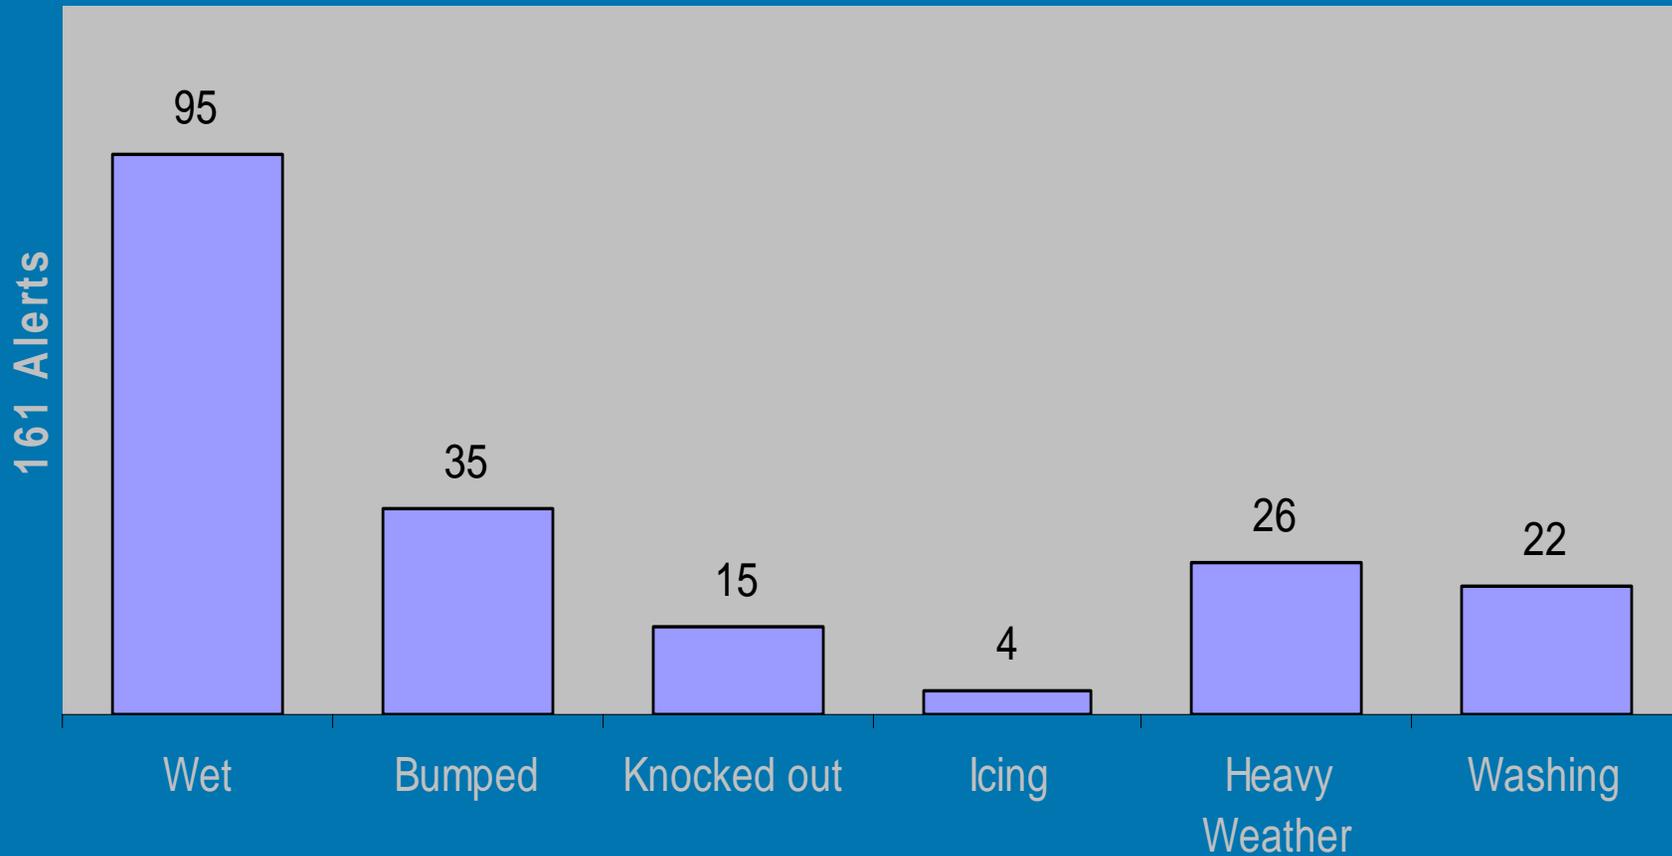
# False Alert and EPIRB in Bracket

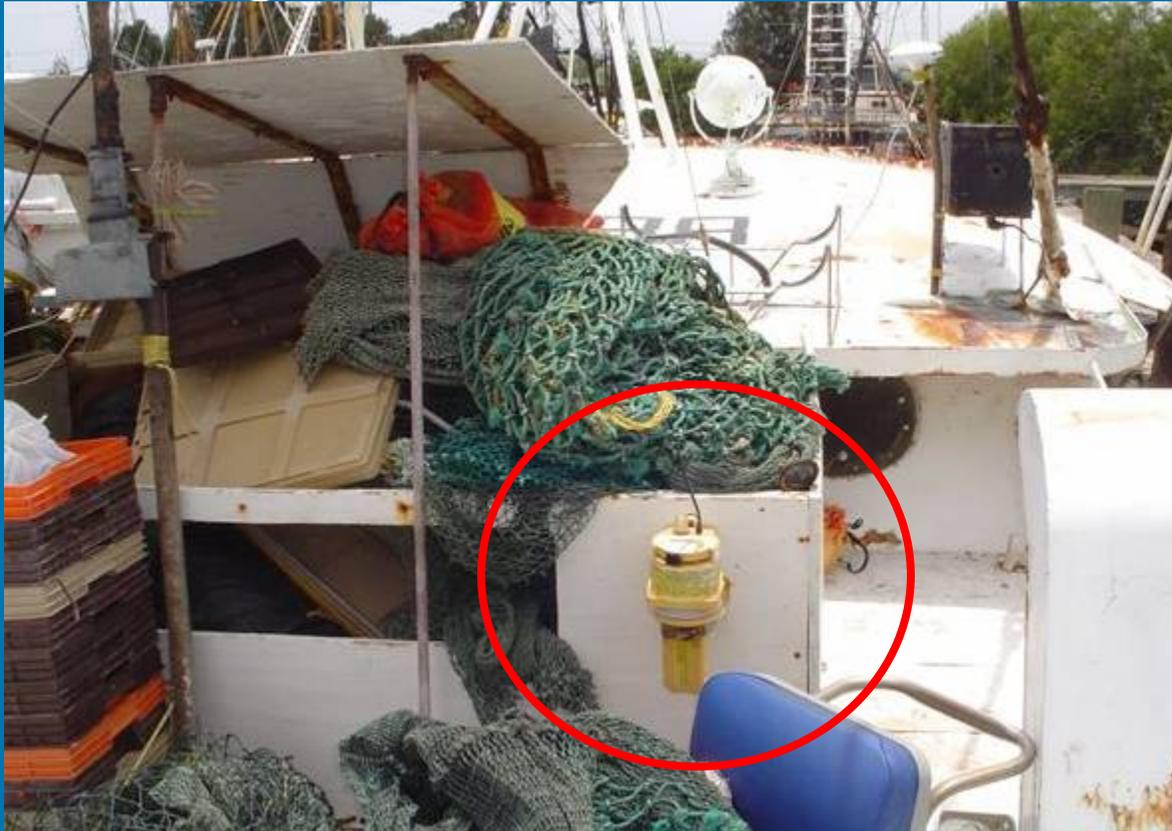
- Mounting Locations – will it float free?

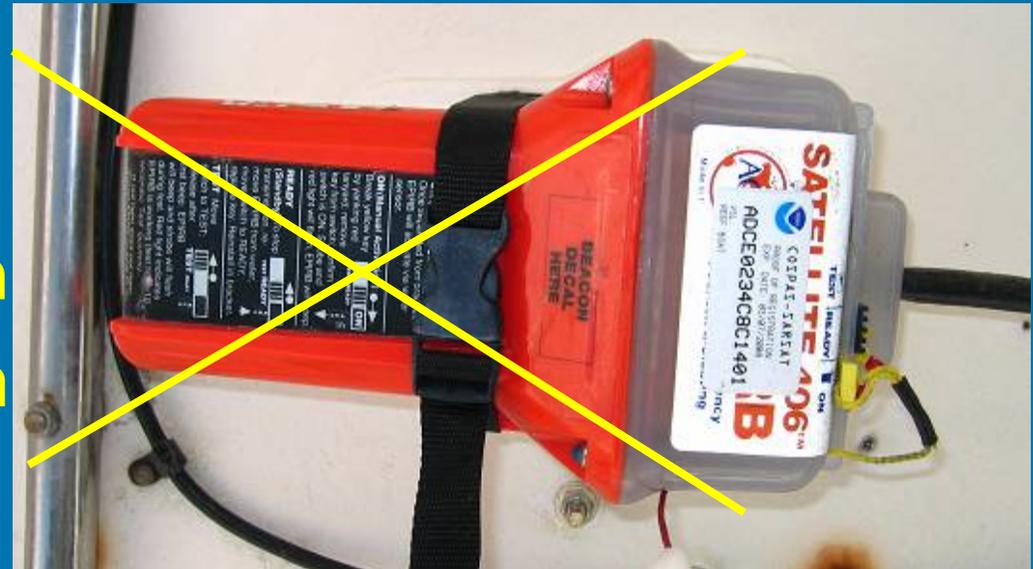
- Mounting Locations –
  - Vertically – Upright
  - Horizontal – Flat on Deck
- Not On Side
- Not Upside-down
- Not hanging from overhead

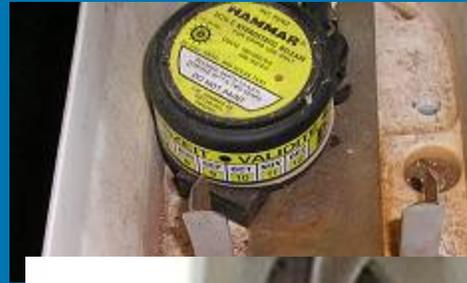
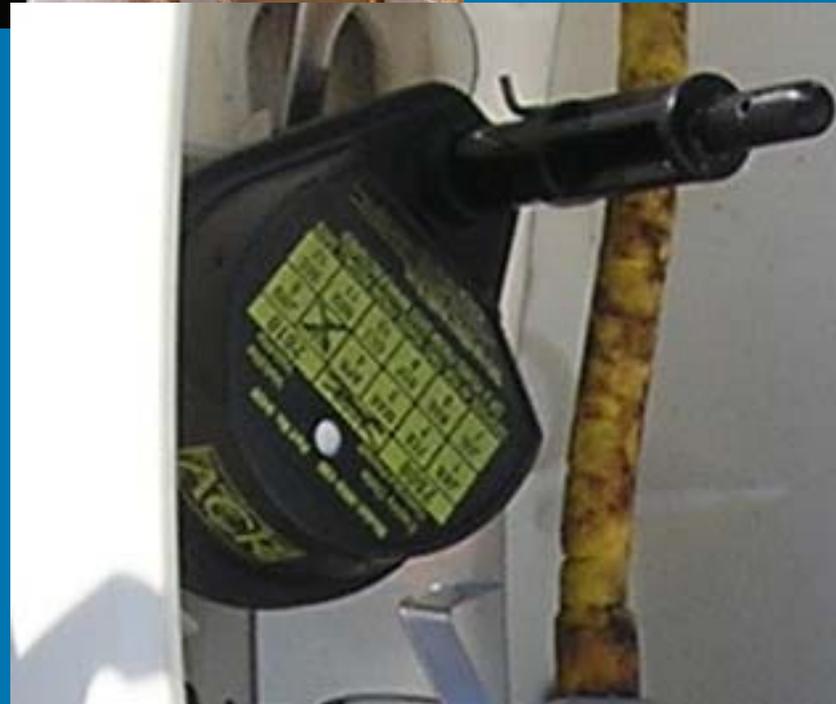
HRU's –  
Hydrostatic  
Release Unit.

- CG Approved (160.062)
- Replace 2 years after purchase
- Installed as designed

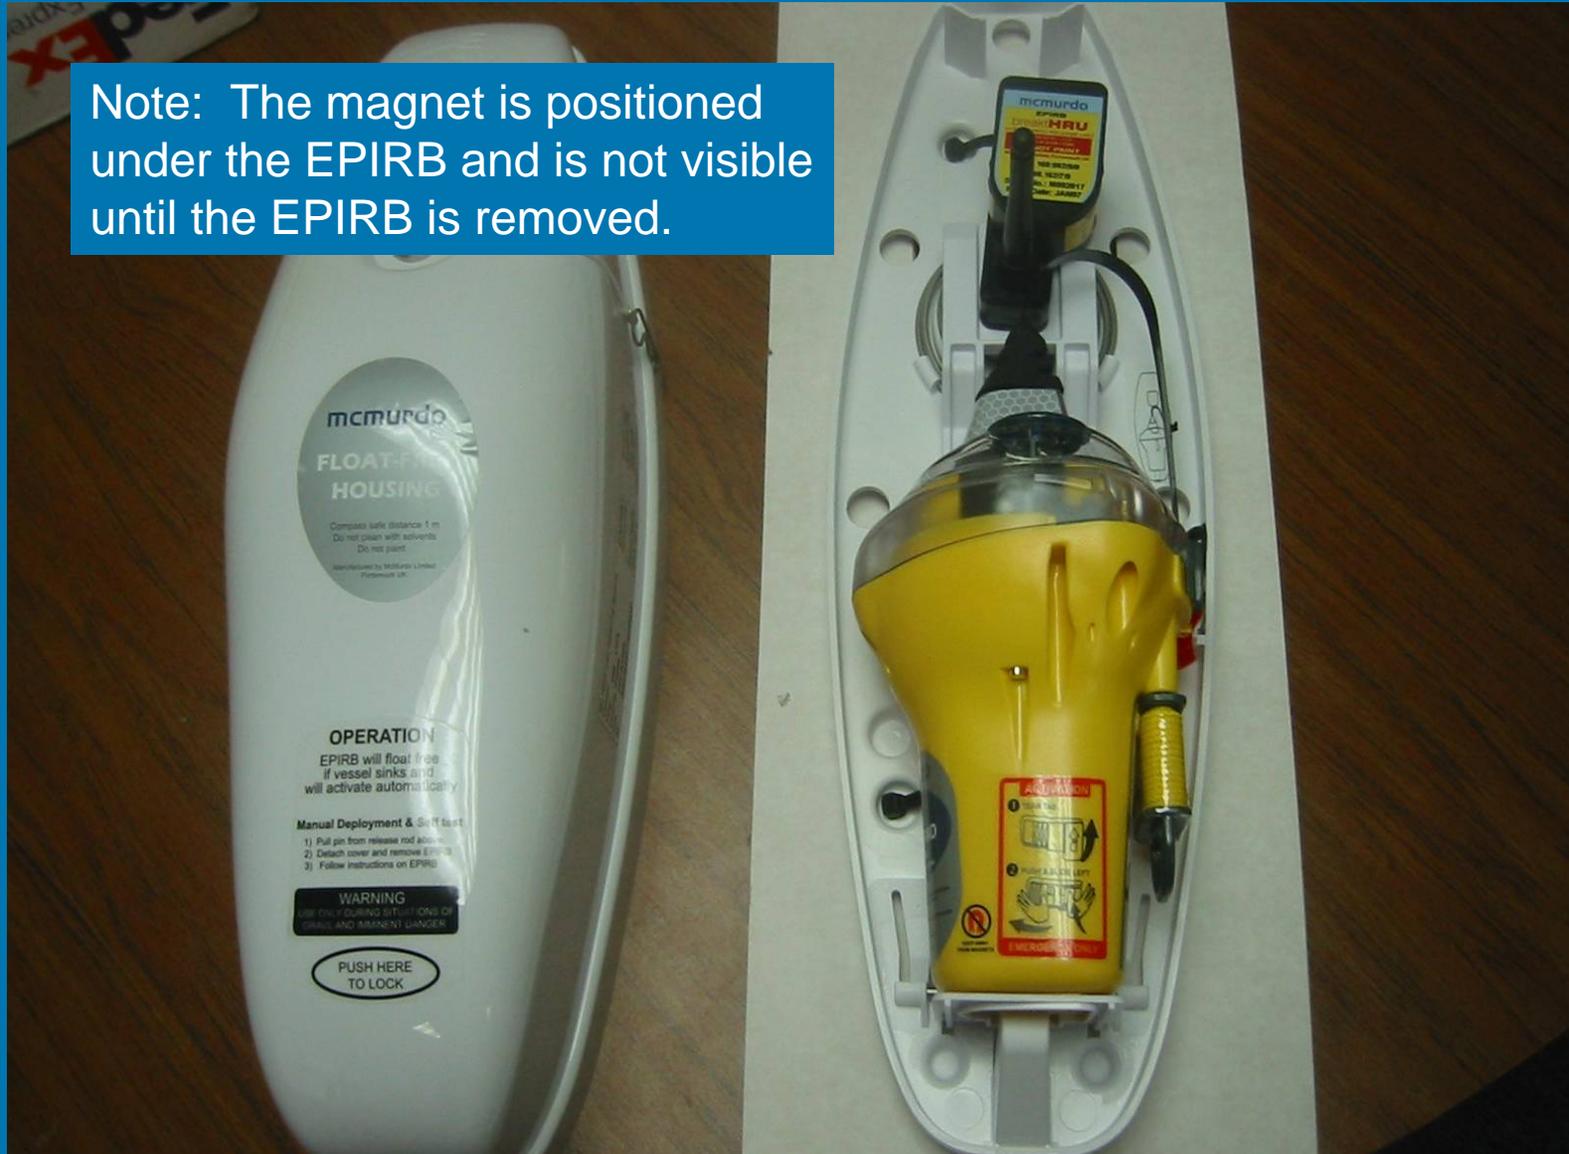
# Category 1 McMurdo 406 GPS

Note: The magnet is positioned under the EPIRB and is not visible until the EPIRB is removed.

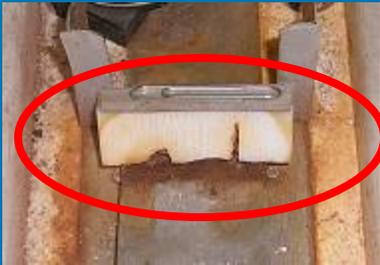
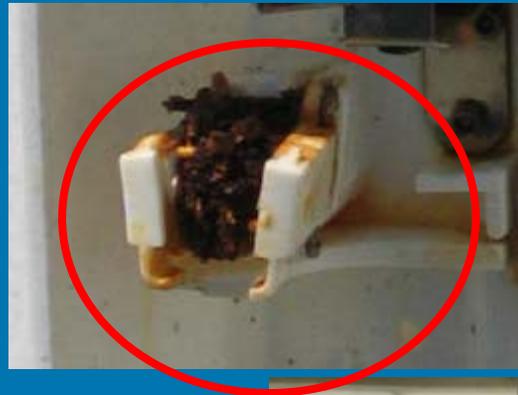
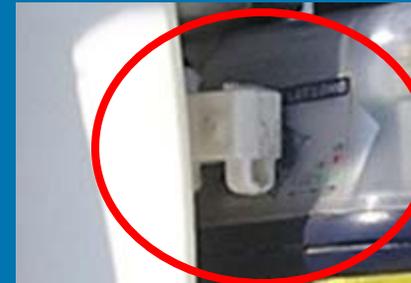
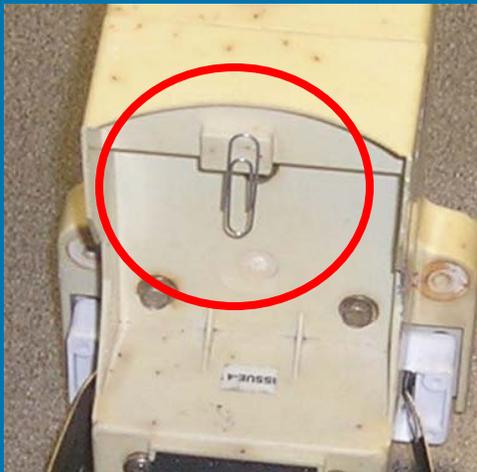
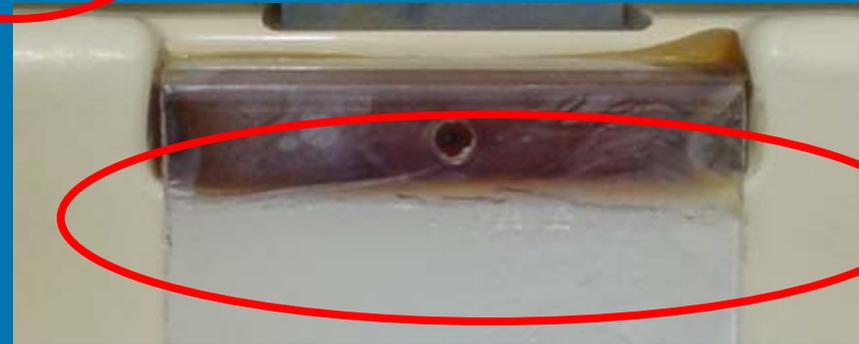
- Magnet on bracket in good condition?

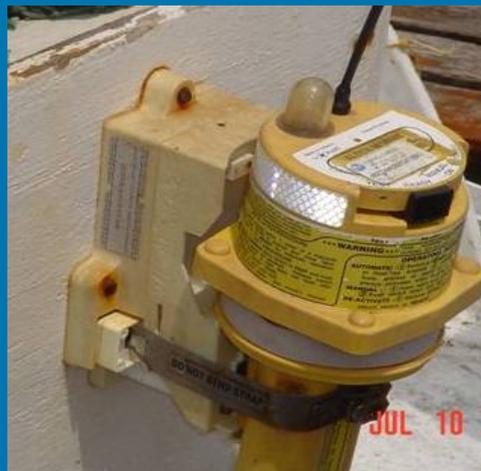
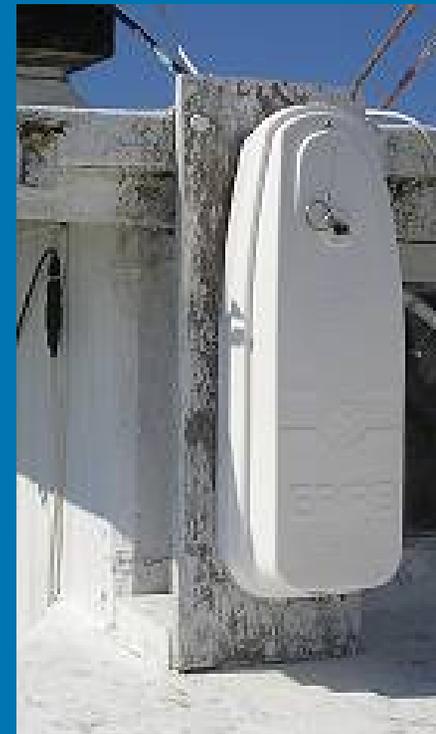
- Bracket
  - Straps – tight
  - Pads and retainers
  - Held firmly

– Less than 1/8" out of place may result in False Alert

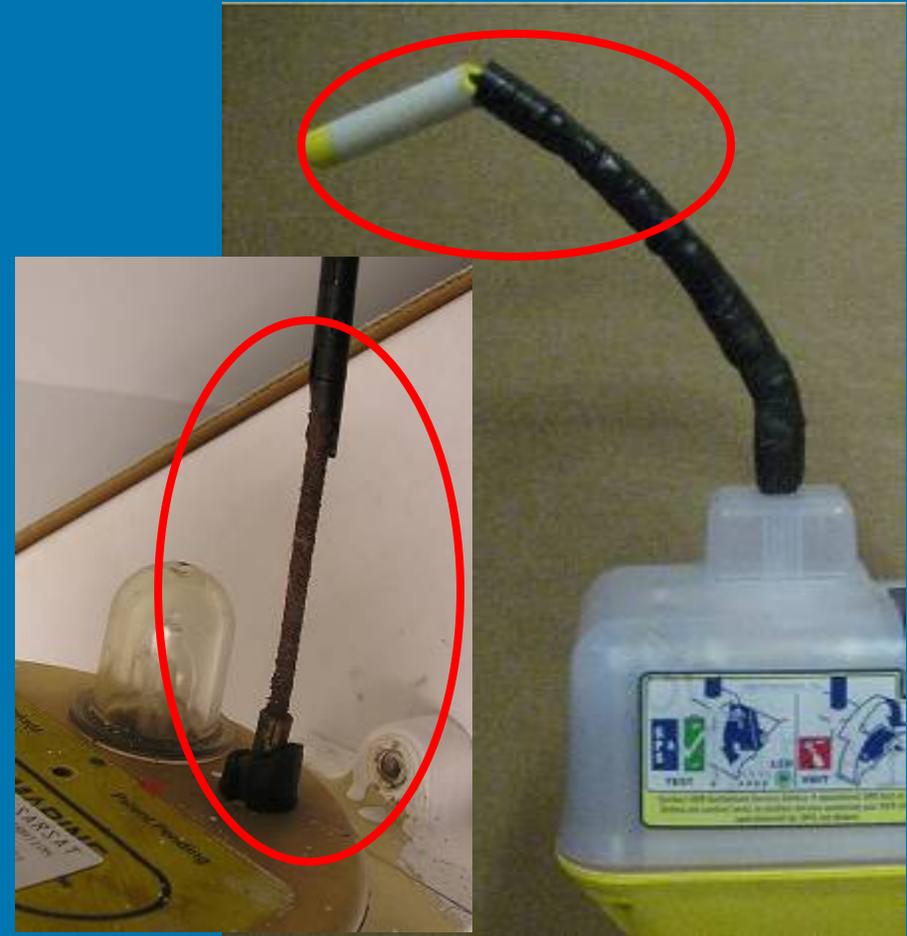
- Antenna –
- In apparent good working order?
  - Most manufactures will replace free if contacted directly.

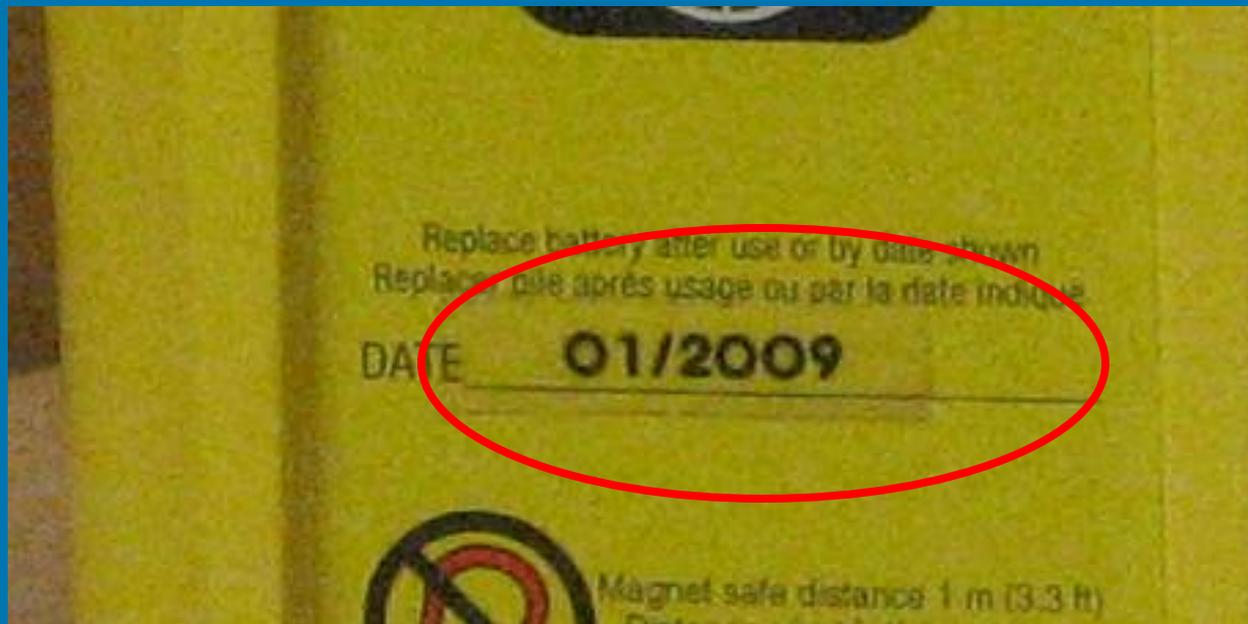
- Battery Exp Date – not expired

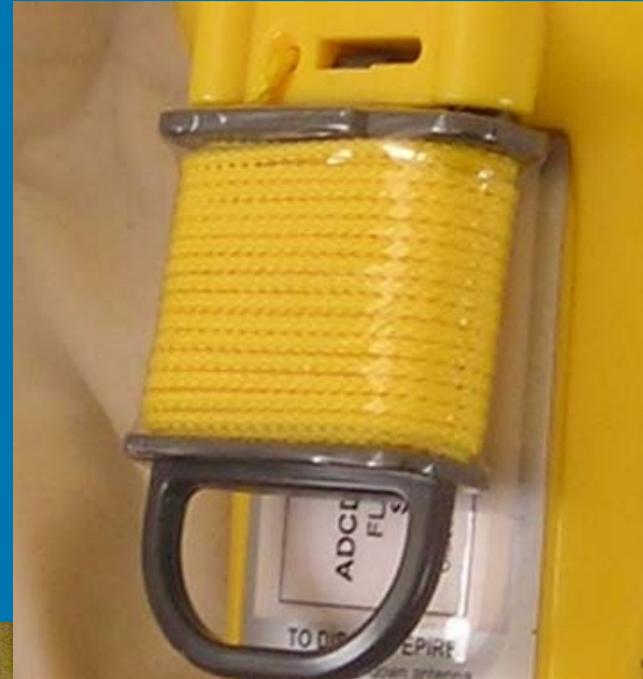
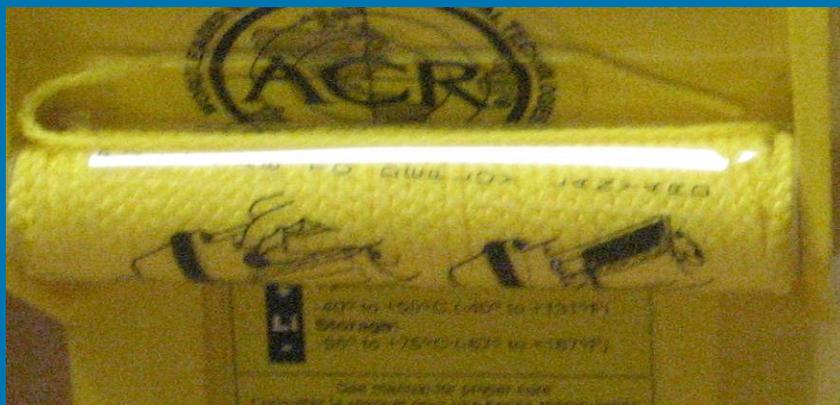
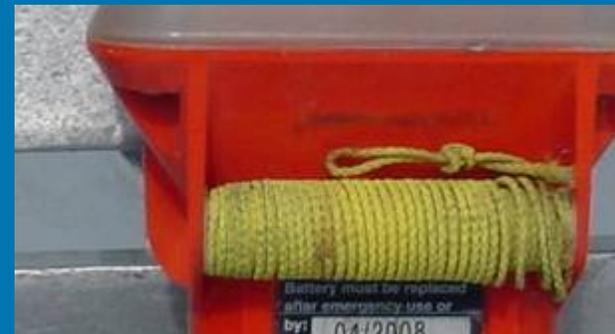
- Lanyard
  - ready to deploy
  - Not dry rotted.
