406 MHz EPIRB False Alerts Study

Study was research project by:

Larry Yarbrough,

USCG District 7 (dpi)

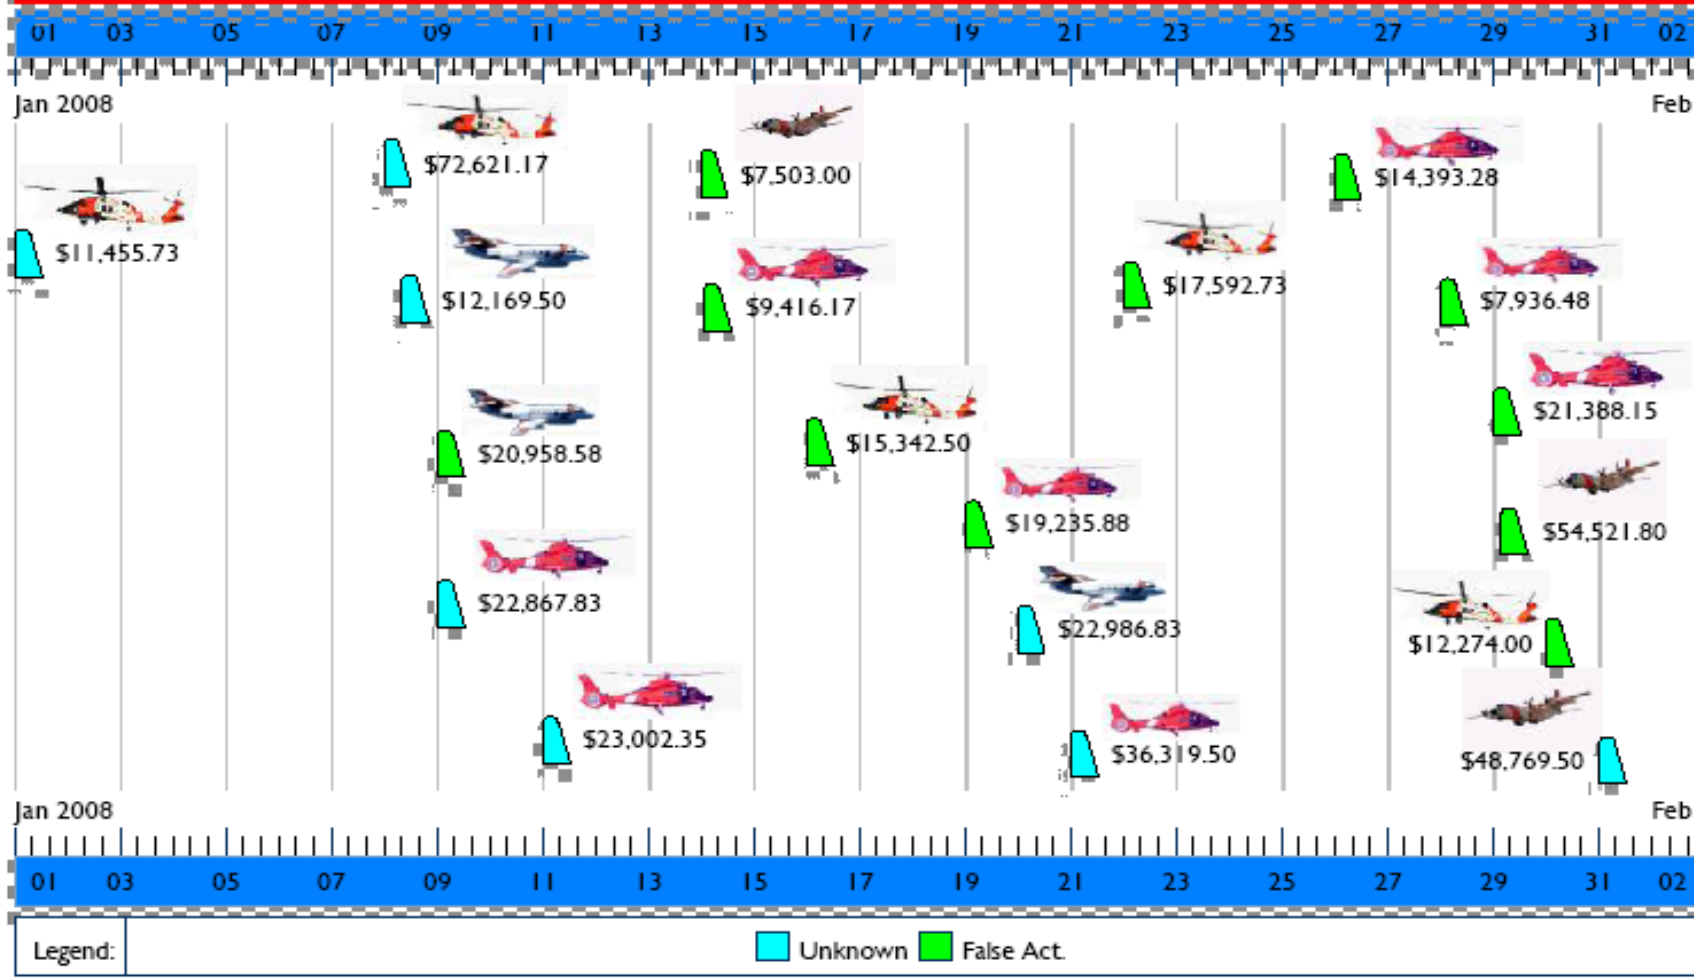
Cost of Coast Guard A/C Sorties Searching for False 406 EPIRB Activations for the Month of January 2008 - \$427,889.15

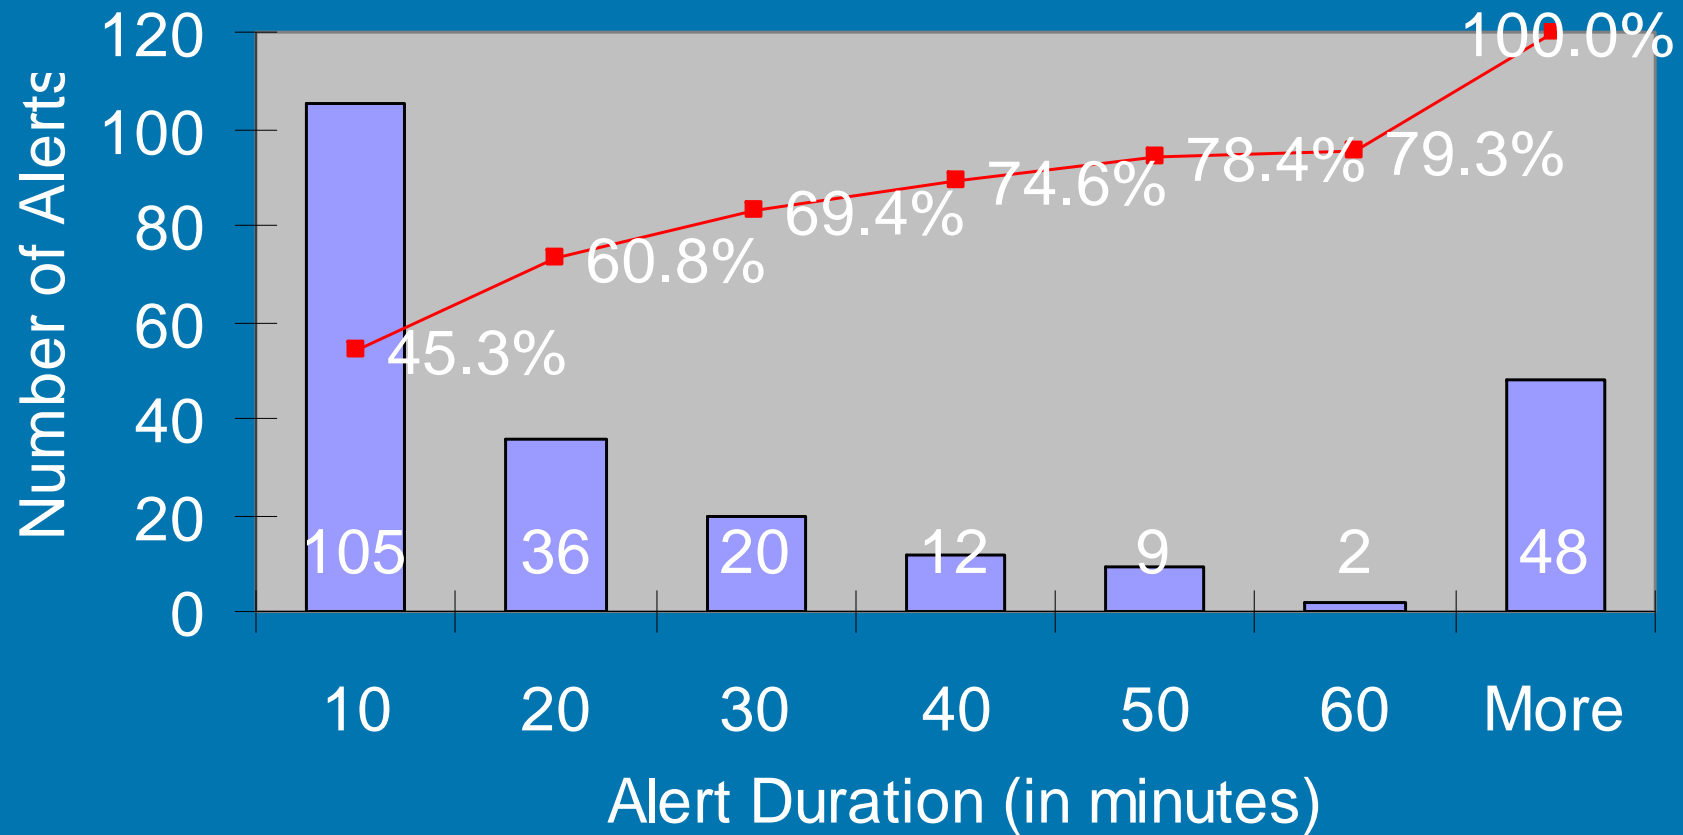
How Long does a False Alerts Last?

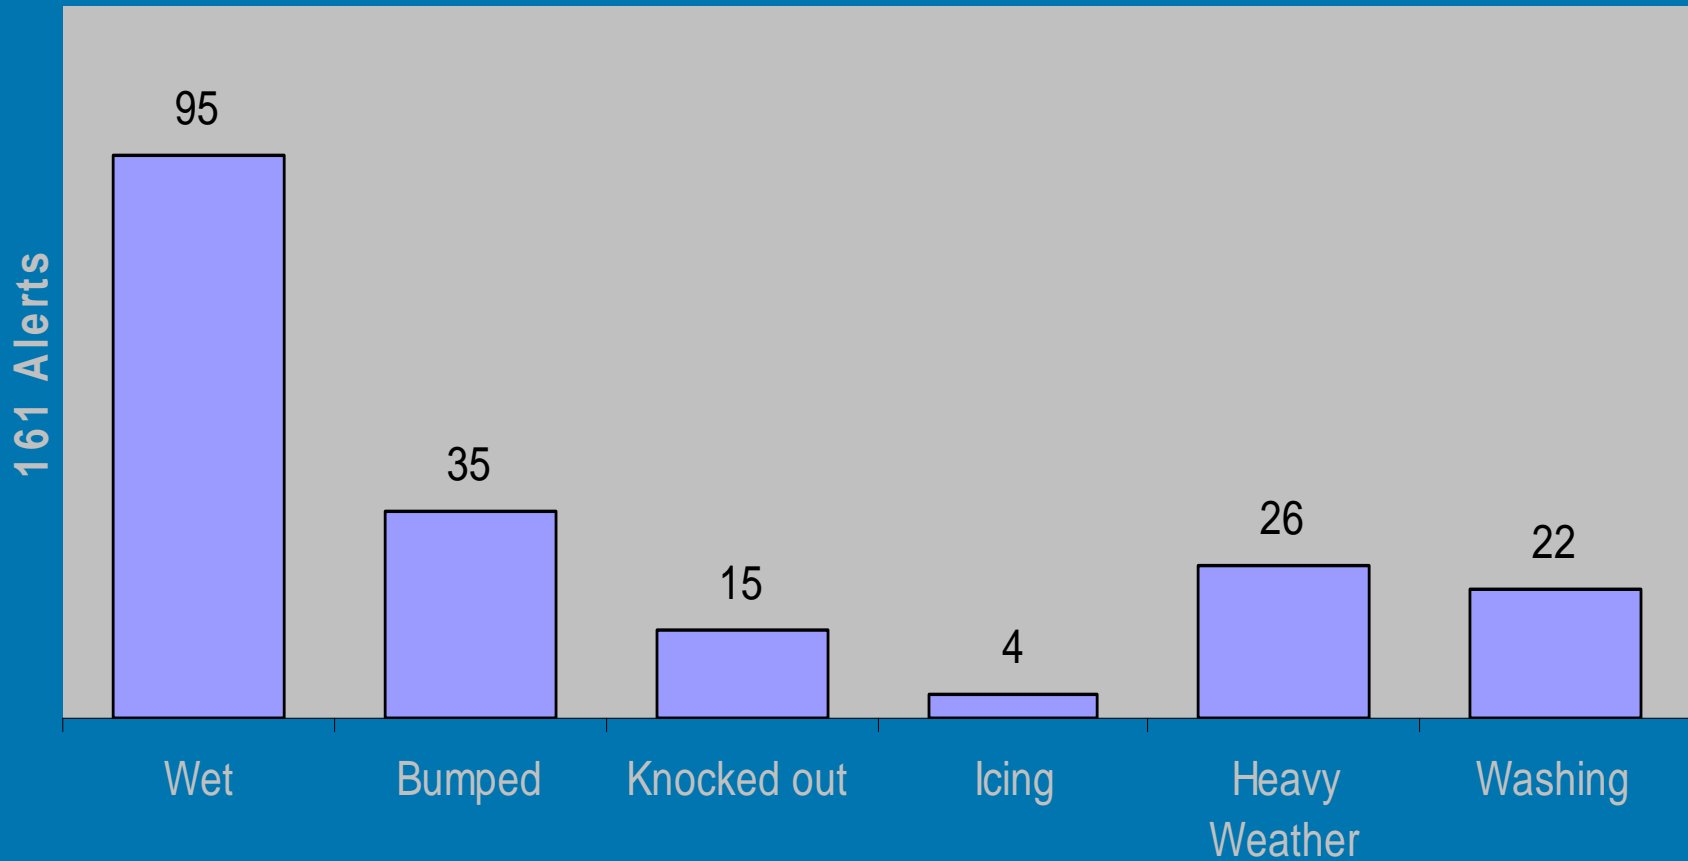
False Alert and EPIRB in Bracket

69% (161) Caused by Failure of “The bracket decoupling function” to control the EPIRB

Require or at least encourage the bracket to be included in an EPIRB service
