# SARSAT System Overview (including Space Segment)

SAR Controllers Workshop 2024
March 19 – 21, 2024
Dr. Laurant Jolly
NOAA SARSAT
Satellite Systems Operations Manager

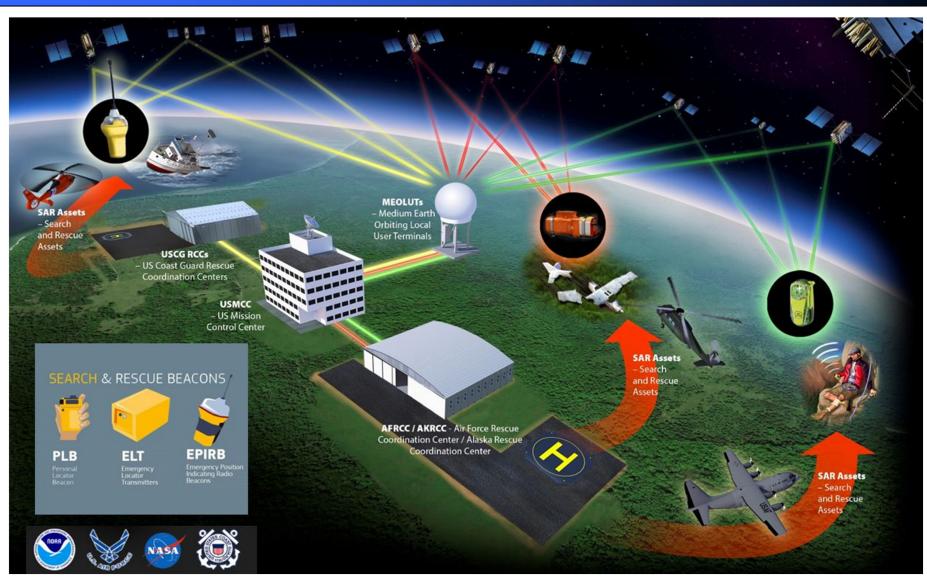
# **SARSAT System Overview**

- Provide an overview of the US operated
   Search and Rescue Satellite Aided Tracking
   (SARSAT) System
  - Space Segment description (US SARSAT controlled)
  - Ground Segment description (US SARSAT controlled)
  - Beacon Segment (User segment controlled, US SARSAT sets policy/type approval)

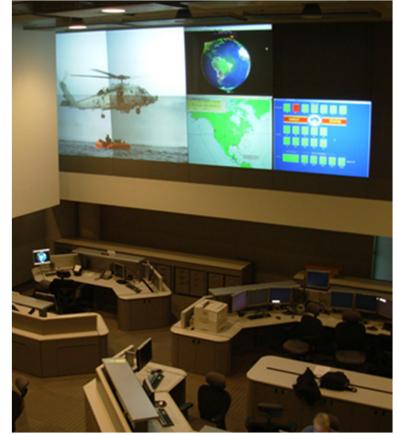
#### United States Mission Control Center (USMCC)

- Receives alerts from national LUTs and foreign MCCs
- Validates, matches, and merges alerts to improve location accuracy and determine the correct destination
- Correlates with NOAA registration database and append info to alert

Located at the NOAA Satellite Operations Facility in Suitland, Maryland

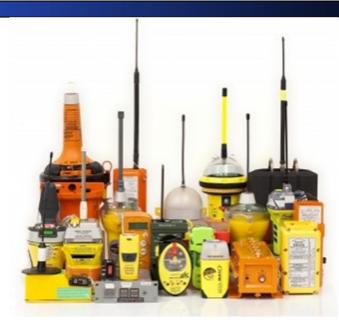
#### **COSPAS-SARSAT Beacons**

#### **Activation:**

- Manual
- Automatic (Hydrostatic/G-Switch)

#### Signal:

- 406 MHz (Digital)
- 121.5 MHz (Analog) Homing

#### Applications:

- Aviation Emergency Locator Transmitter (ELT)\*
- Maritime Emergency Position-Indicating Radio Beacon (EPIRB)
- Personal/Land Personal Locator Beacon (PLB)
- Security Ship Security Alert System (SSAS)

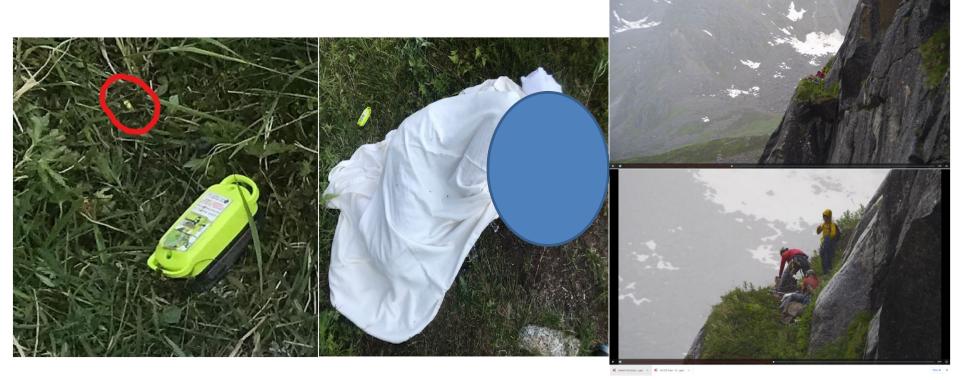
#### **Incident Assessment**

- Incident pictures captured the survivor providing a view of the PLB deployment (The GPS location was embedded in the photos on the phone).
- The PLB was upside down with the antenna bent.
- Antenna was laying on the ground unable to verify for how long.
- Significant terrain masking due to the incident location (high mountains and rock face).

- The original test data from the PLB factory birth record (2017) was within specification and passed all tests
- The PLB was labeled correctly with a current and correct UIN.
- The returned unit had a pronounced antenna kink consistent with the picture of the PLB position at the accident site
  - The PLB battery measured the correct voltage
  - The unit did not pass self-test
  - The unit did not pass GNSS self-test
  - Battery was changed and self-test still failed
  - Subsequent circuit inspection reveals a damaged power amplifier
  - Replacement of the power amplifier resulted in a fully functional unit sans the antenna.
